TECHNICAL REPORT CERC-84-6

HURRICANE ALICIA STORM SURGE AND WAVE DATA

Coastal Engineering Research Center

Final Report

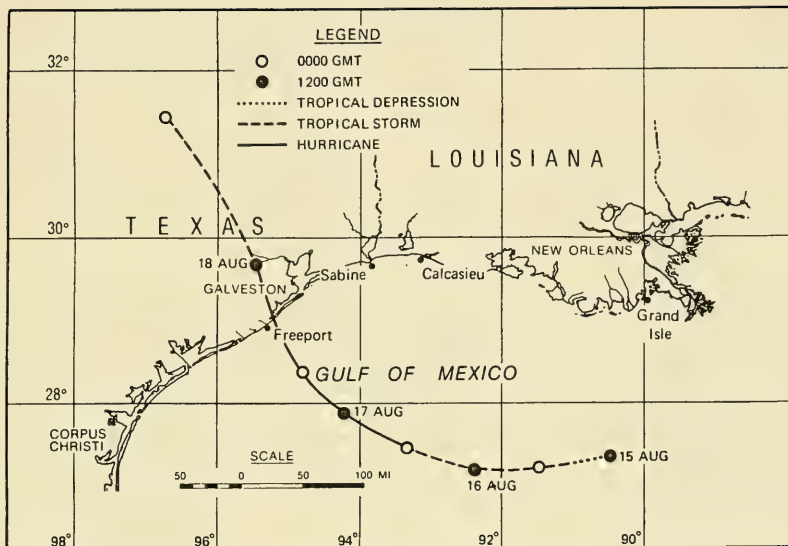
Figure 1. Approximate track of hurricane Alicia

6. Alicia was officially classed as a hurricane at 0000 Greenwich mean time (GMT) 17 August 1983. Central pressure was 991 mb with maximum sustained winds of 75 mph. The hurricane continued to intensify until it made landfall at the western tip of Galveston Island, Texas, at approximately 0700 GMT 18 August. Central pressure was 963 mb with maximum sustained winds of about 115 mph. Table 1 is the best track information available as of February 1984. Radar imagery indicates Alicia may have developed a double-eye structure subsequent to landfall. The two eyes probably did not always exist simultaneously, thereby causing the hurricane track to appear very erratic if eye position is used to determine the track. Use of a mass field envelope technique will probably result in a much smoother track. After moving north of Houston, Alicia weakened steadily and was classed as a tropical depression at 0600 GMT 19 August. Figure 1 shows the approximate track of Alicia.

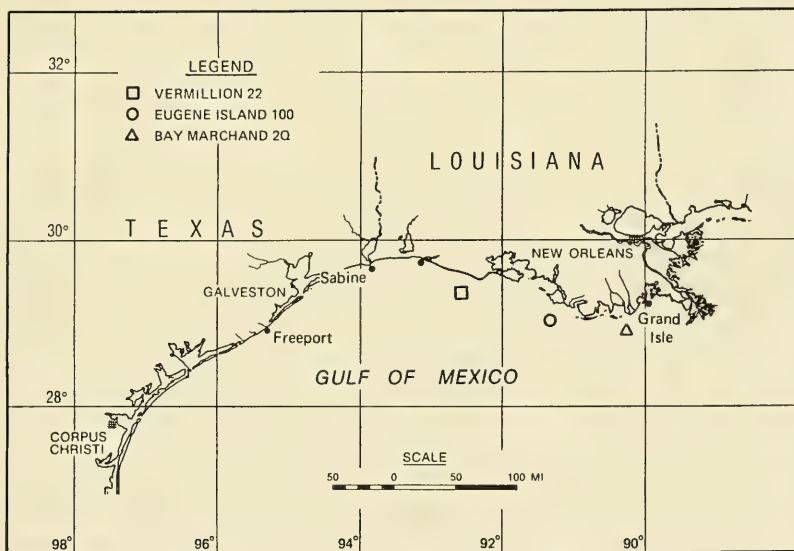
Figure 3. Location of Shell Oil Company platforms off Louisiana coast

22. During Alicia's passage through the Gulf of Mexico, CERC was operating wave and tide gages on three Shell Oil Company petroleum platforms off the south Louisiana coast. The locations of the platforms are shown in Figure 3. The positions and nominal water depths of the platforms are:

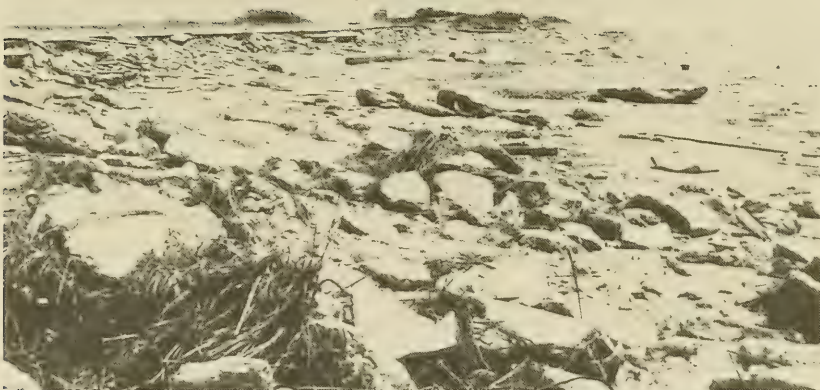
Photo 2. Highway damage on Follets Island 2 miles
west of San Luis Pass

26. At the US Coast Guard Station in Freeport near the mouth of the Old Brazos River, high water overtopped a low bulkhead approximately 3 ft above the normal water line but caused minimal flooding of the station itself (Photo 1). Nearby in Surfside Beach, the surge and wave setup breached the primary dune and damaged the coastal highway which is at an elevation of +8 ft NGVD. Between Surfside Beach and San Luis Pass, the approximate point of landfall, the surge overtopped the roadbed at an elevation of +8 ft NGVD and caused extensive damage to the highway (Photos 2-4). The entire eastern tip of Follets Island at San Luis Pass appeared to have been inundated by the surge.

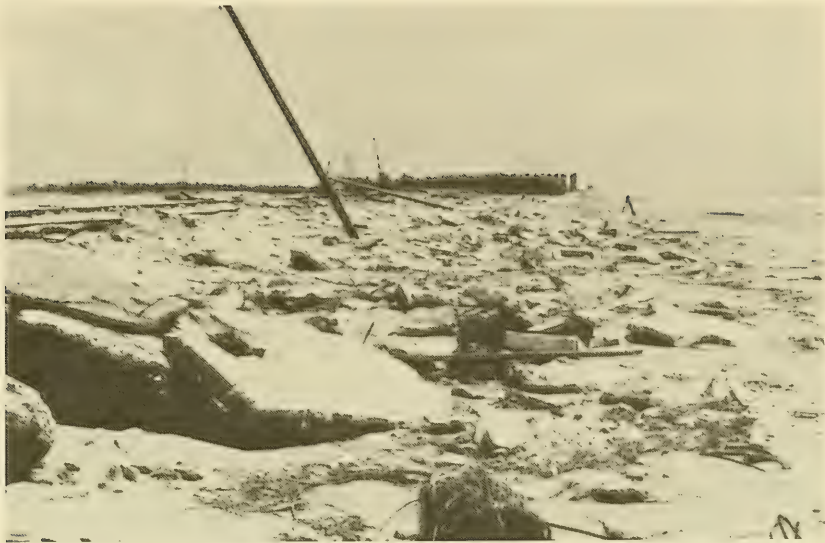
Photo 3. Highway damage on Follets Island near San Luis Pass

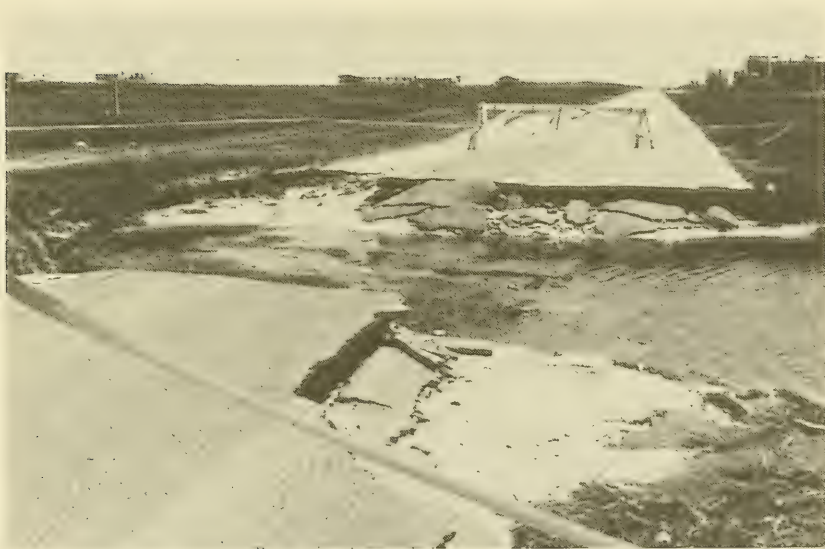
Photo 4. Highway damage near eastern end of Follets Island

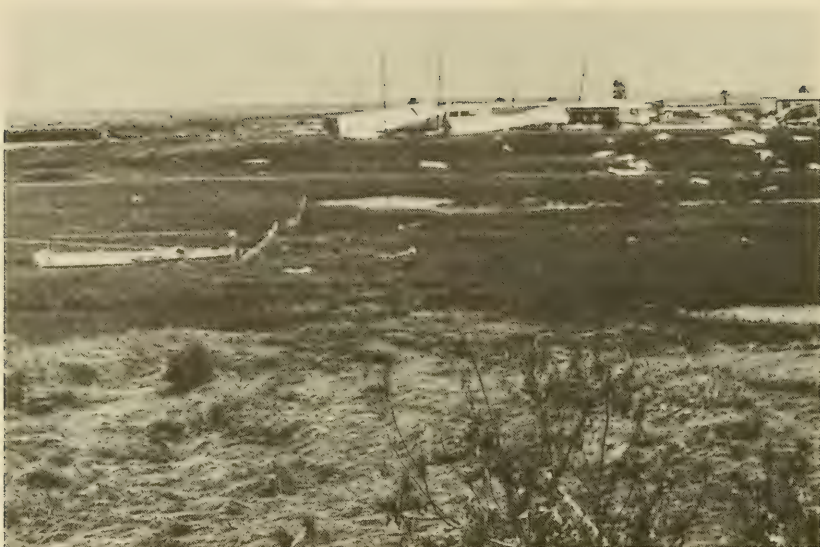
Photo 5. Damaged mobile homes and debris on East Beach, Galveston

residences and commercial buildings and leaving large debris piles at the base of the seawall (Photos 5-7). Surge levels on the Bolivar Peninsula reached +7 to +8 ft NGVD between the western end of the peninsula and Crystal Beach, rising from both the Gulf and Bay sides of the peninsula but failing to inundate Highway 87 and many homes built on high ground along the highway. Photo 8 shows several homes on the beach damaged or destroyed by the storm; however, most homes further inland showed signs of wind damage but no flooding damage. At High Island, 50 miles east of the point of landfall, the surge reached +4 to +5 ft NGVD, flooding extensive low-lying marsh areas and depositing large amounts of sand on Highway 87 (Photos 9 and 10).

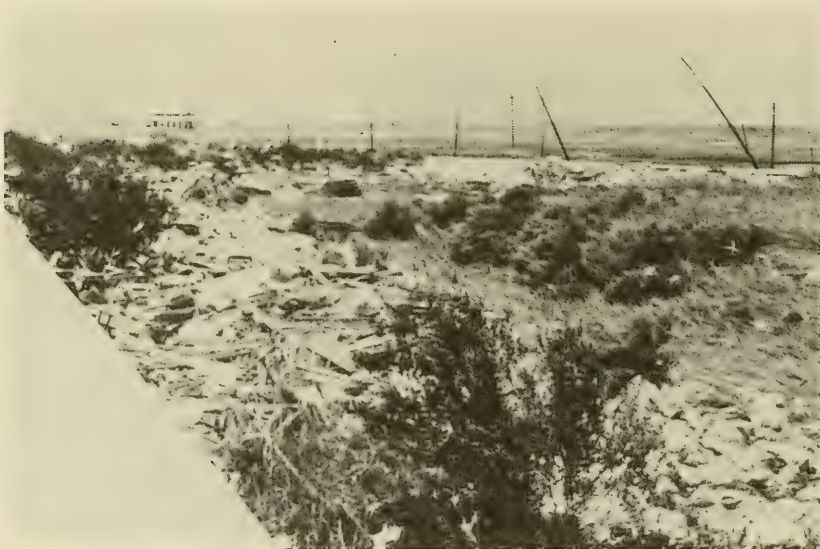
Photo 6. Debris line at foot of seawall, East Beach, Galveston

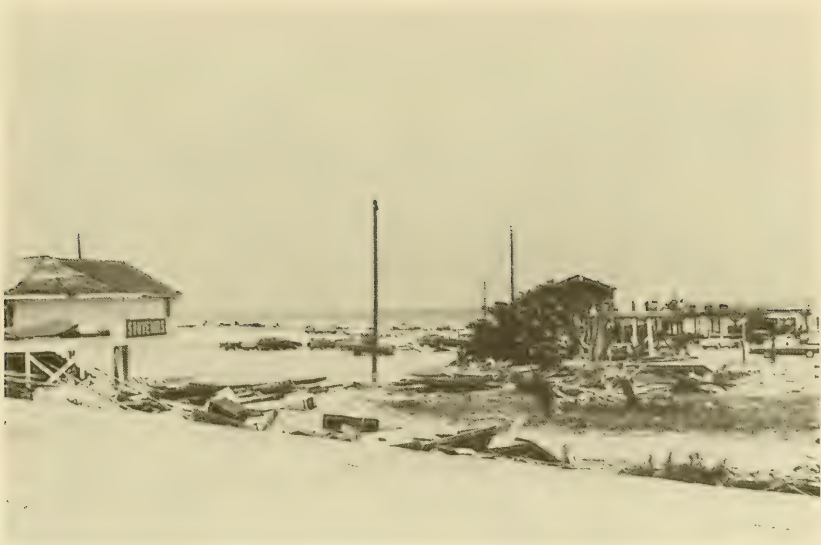
Photo 7. Damage to commercial property on East Beach,
Galveston Island

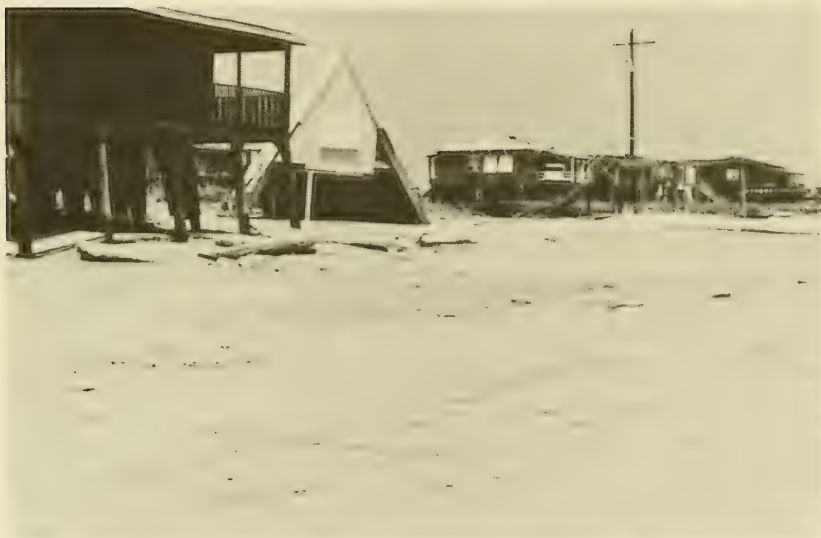
Photo 8. Damage to beachfront homes at Crystal Beach,
Bolivar Peninsula

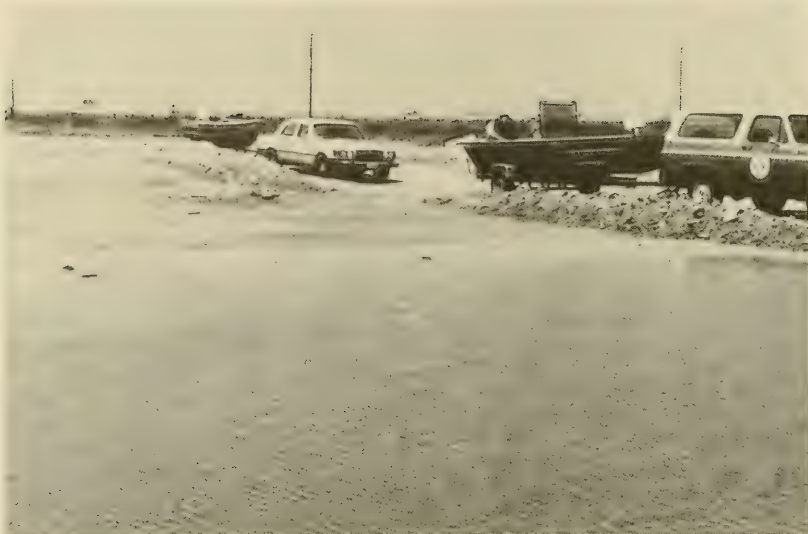
Photo 9. Overwash deposits on Highway 87 at High Island

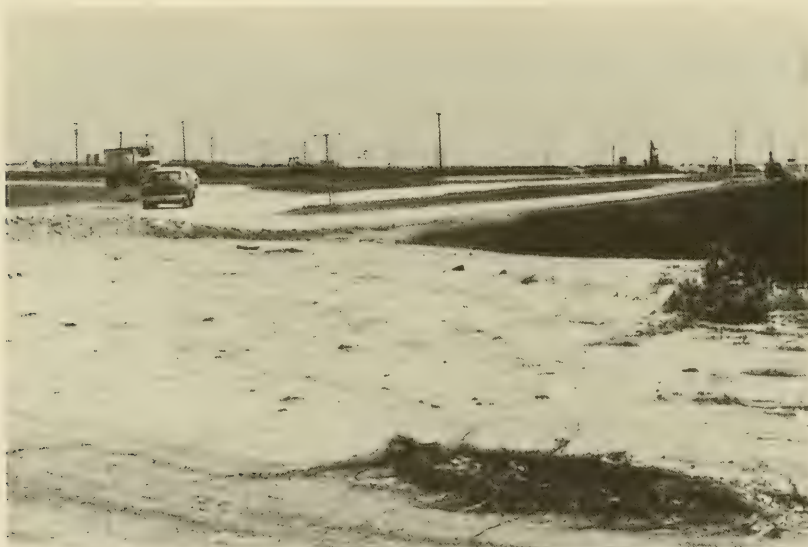
Photo 10. Overwash deposits at intersection of
Highways 87 and 129 on High Island

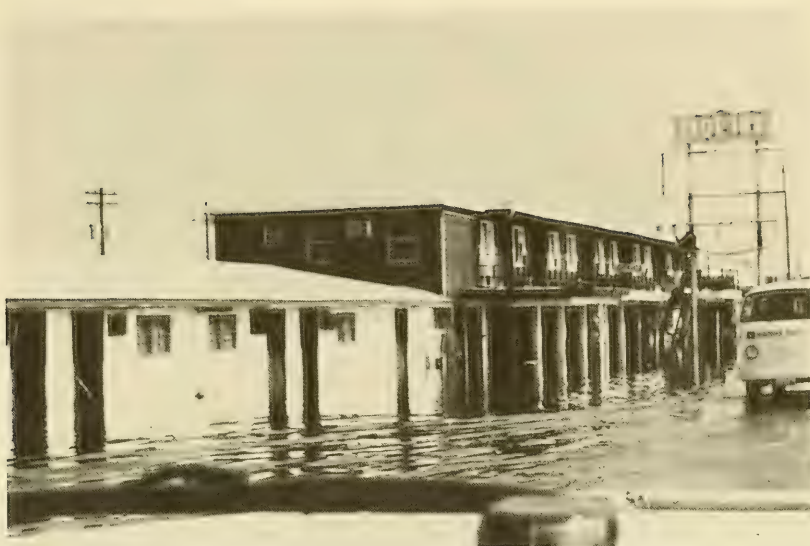
Photo 11. Residual flooding at Seabrook, Texas, 21 August 1983

29. At Virginia Point, just north of Galveston Island, the surge covered the Gulf Freeway up to approximately +7 ft NGVD, cutting off all access to the island during the height of the storm. The Texas City dike was overtopped along most of its length, but the Texas City levee system protected the city from surge-induced flooding. The surge along this section of the bay is estimated to have been between +7 and +10 ft NGVD. At Seabrook, 15 miles north of Texas City, the storm surge reached approximately +9 ft NGVD. The water level remained considerably higher than normal in this area for at least 3 days after landfall (Photo 11).

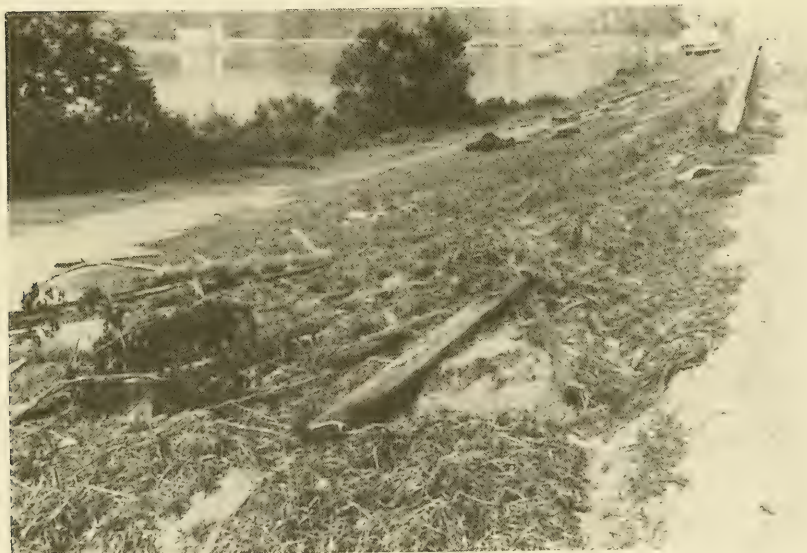
Photo 12. Debris line and stranded tug on Highway 146 embankment,
Baytown, Texas

30. High water marks on the Highway 146 bridge at Baytown indicated a surge at the north end of Galveston Bay of approximately +10 ft NGVD. Photo 12 shows the eastern end of the bridge causeway. The water level in this area rose 3 to 4 ft above normal by the morning of 17 August and remained several feet higher than normal for at least 3 days after landfall. East of Baytown, in the Houston Point area, the shoreline is backed by bluffs 15 to 20 ft high which prevented significant surge damage. No definite high water marks were located in this area.

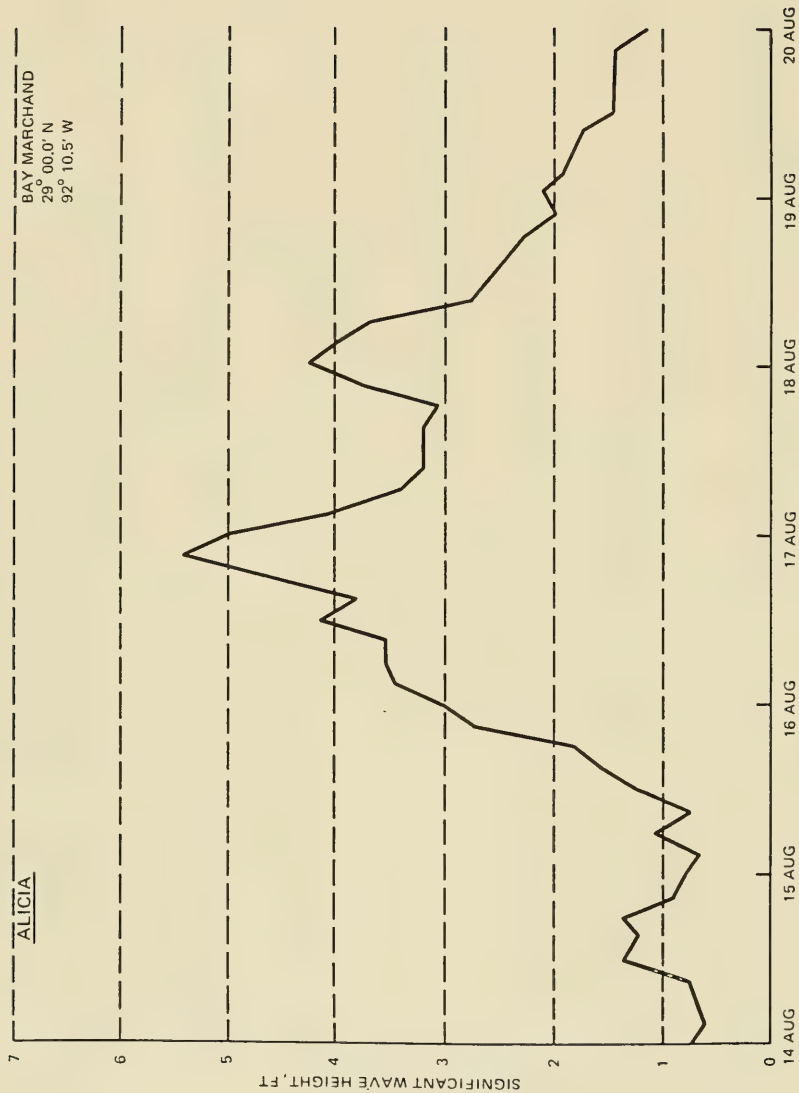
Plate 17. Significant wave height during passage of Alicia,
Shell platform Bay Marchand

23. Plates 15-17 are the significant wave heights at each of the platforms during the storm passage. The wave data were acquired by using a sub-surface pressure sensor and a self-contained, internally recording digital data logger. The pressure records were cosine tapered and spectrally analyzed by means of a Fast Fourier Transform algorithm. Each spectral component was then corrected for depth attenuation by using linear-wave theory and the periodogram block averaged resulting in a spectrum with 32 equivalent degrees of freedom. Spectral plots of the wave data acquired during Alicia's passage are contained in Appendix A.

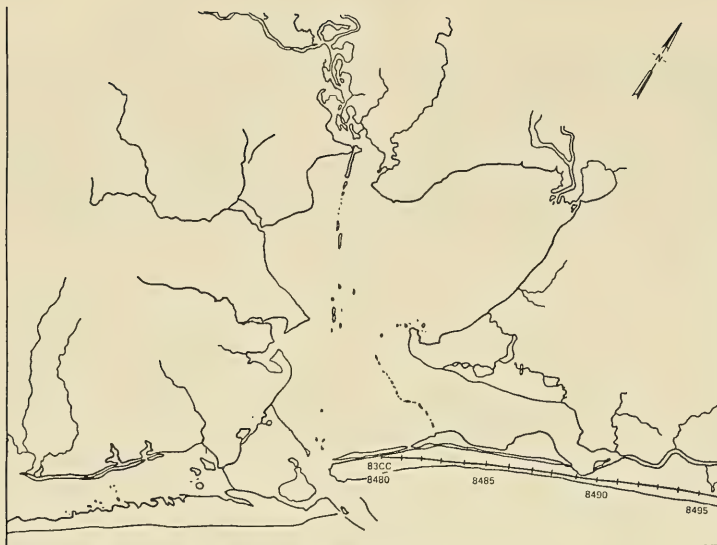
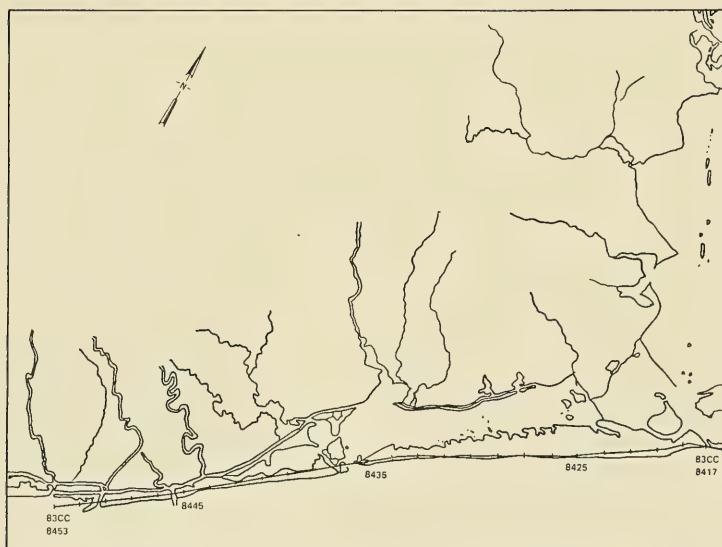
APPENDIX C: INDEX OF AERIAL PHOTOGRAPHY

This Appendix shows the flight lines and photograph numbers for color aerial photography of the Texas Gulf Coast taken on 24 August 1983. Copies of these photographs are available from the National Ocean Service in Rockville, Maryland. Each photograph covers an area of approximately 18 square miles at a scale of 1:30,000. The flight lines cover the coastal area between High Island and the eastern end of Matagorda Bay.
